Village Ponds in Basdharma

KARNAL, HARYANA

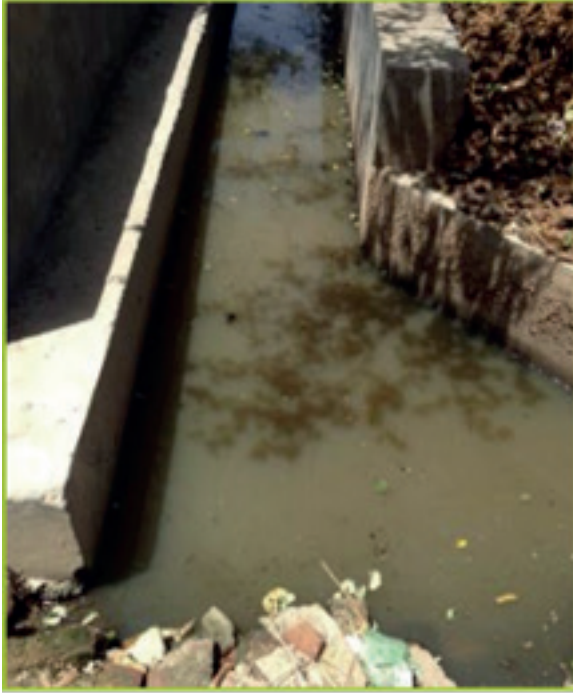
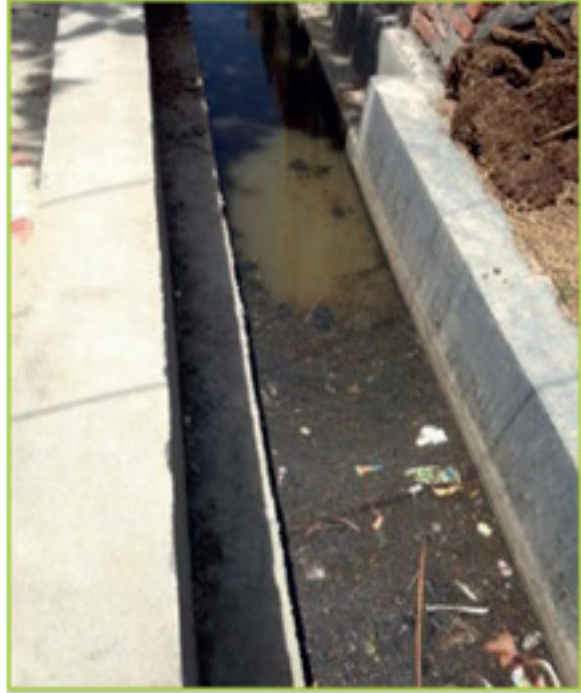
Open drains carrying all waste into pond

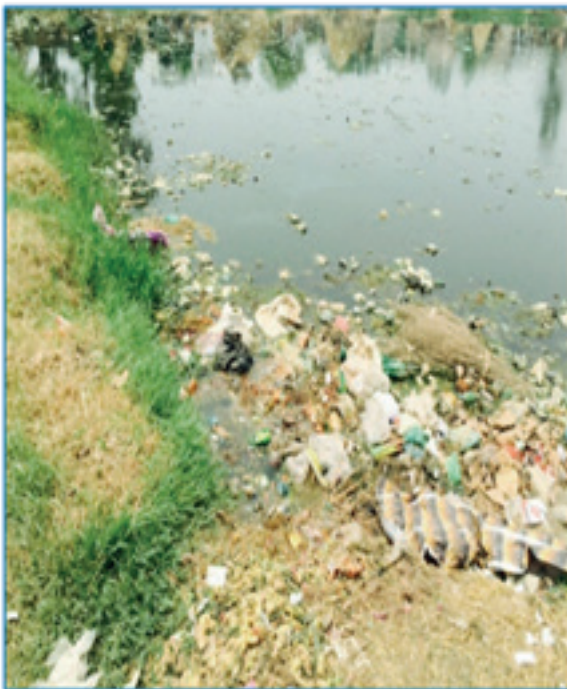
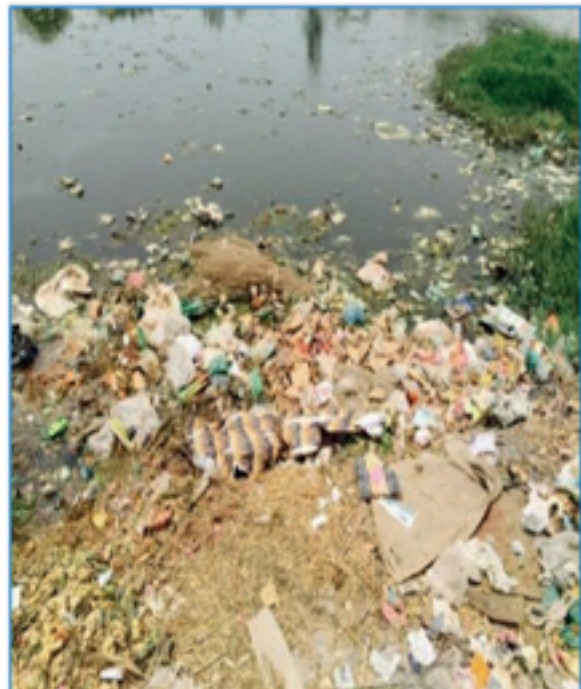
Waste and plastic on the bank of pond

The colour of water changed and algae had vanished completely. However, there was a lot of plastic bottles and dry garbage being left on the bank of the lake which was eventually cleaned up after treatment to restore the health of its surroundings.

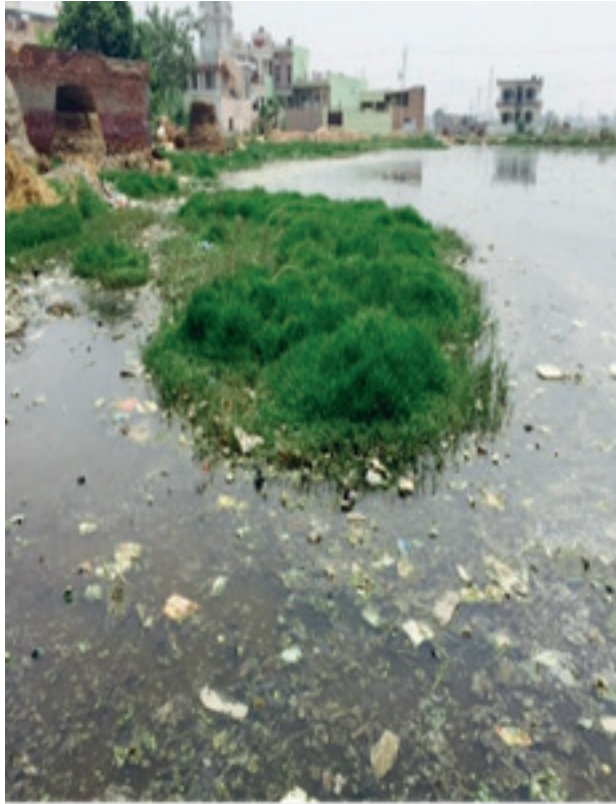
**Pond Before
treatment
as on
09th April 2015**

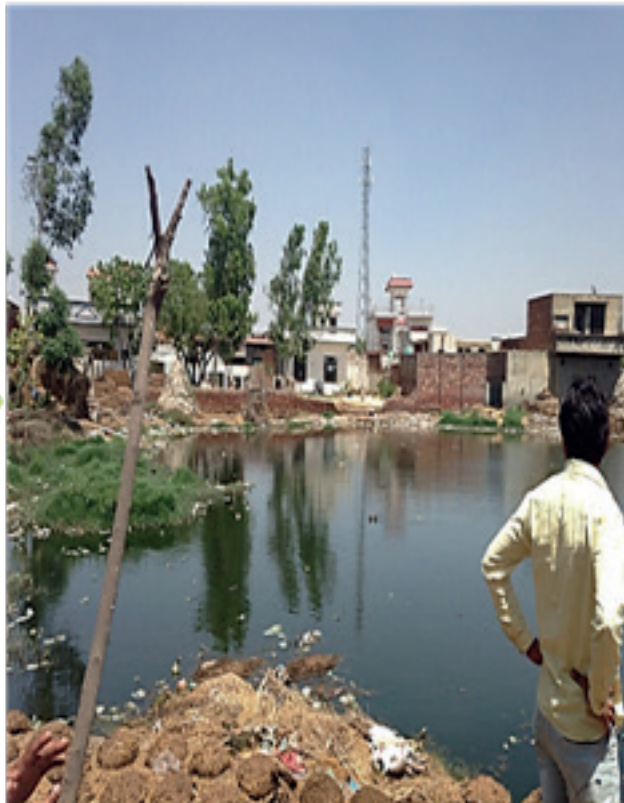
**Pond After
treatment
as on
11th May 2015**

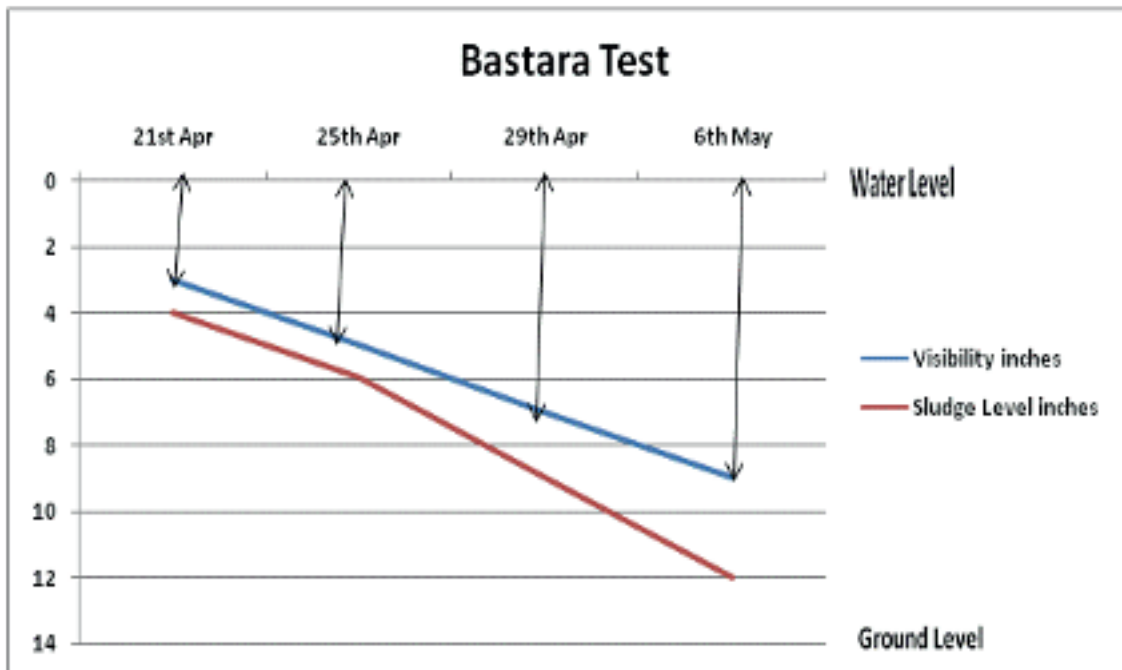
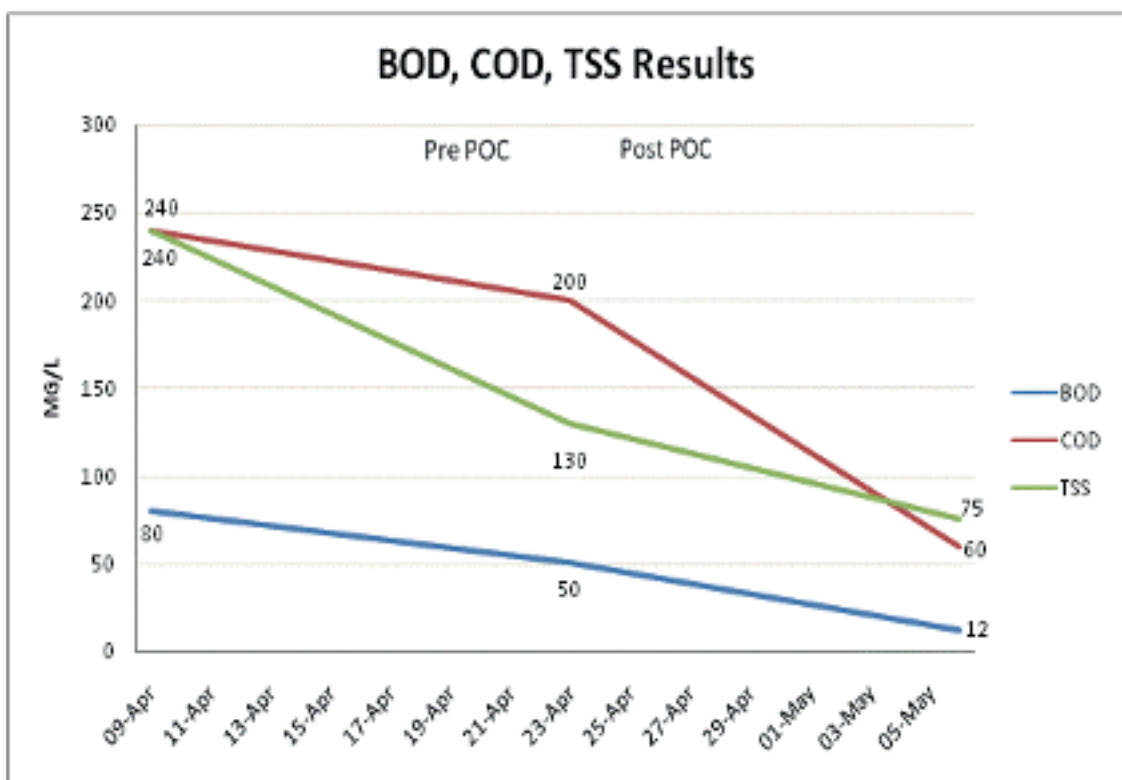
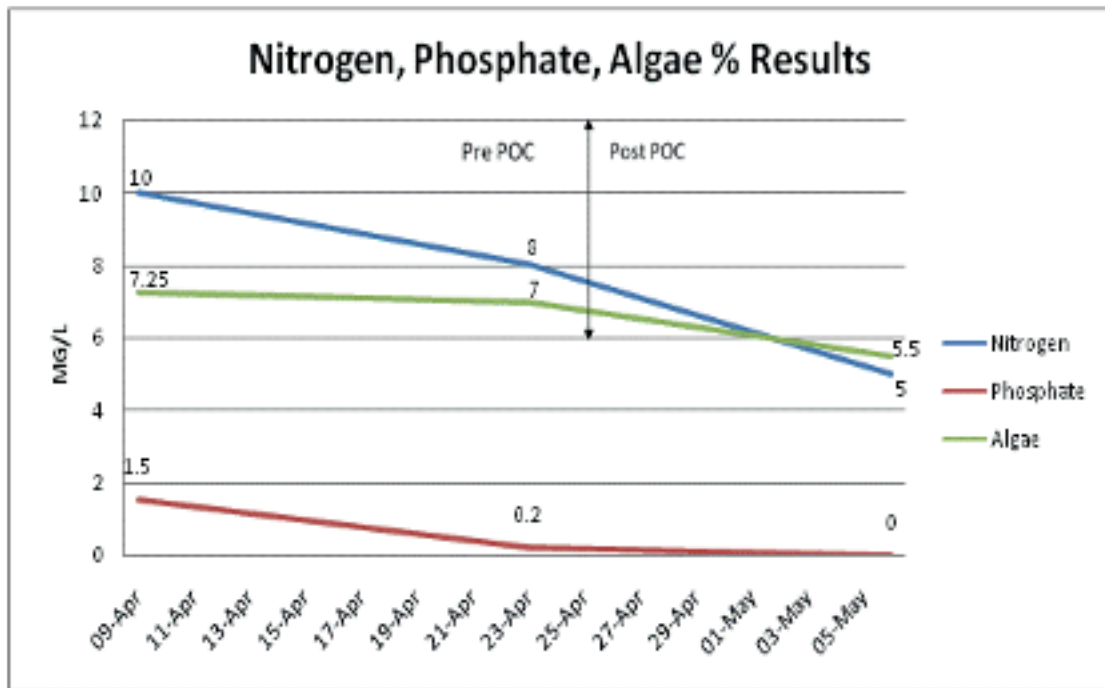
Figure: POC Village Ponds in Basdhara, Karnal, Haryana (Water Quality Tests)

Visibility test conducted at 5 different locations of the lake with Secchi disk revealed an increase in visibility from 3 to 9 inches in 2 weeks and sludge too had settled down. Approximately 1,188,000m³ of sludge was removed in just 2 weeks.
